Section 2 Public and Common Use Areas

The public and common use areas of Jefferson Pines Apartments are required to be readily accessible to and usable by persons with disabilities. The public and common use areas of this complex include the following:

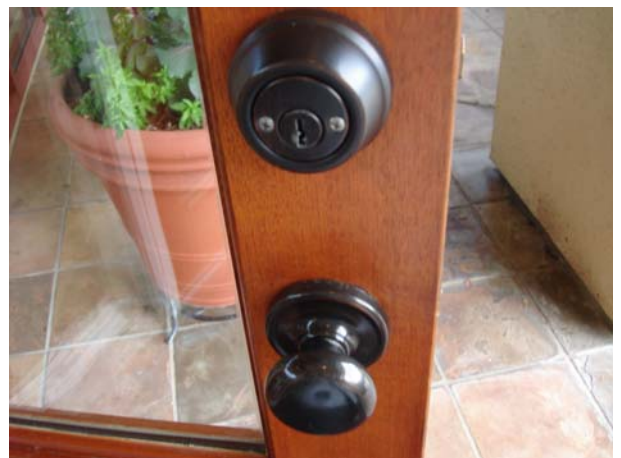
Interior door knob at leasing office (#9979)

The interior hardware at the leasing office front door was knob style hardware. Knobs are not accessible hardware. “Handles, pulls, latches, locks, and other operating devices on accessible doors shall have a shape that is easy to grasp with one hand and does not require tight grasping, tight pinching, or twisting of the wrist to operate.” (ANSI 4.13.9, ADA Std.4.13.9)

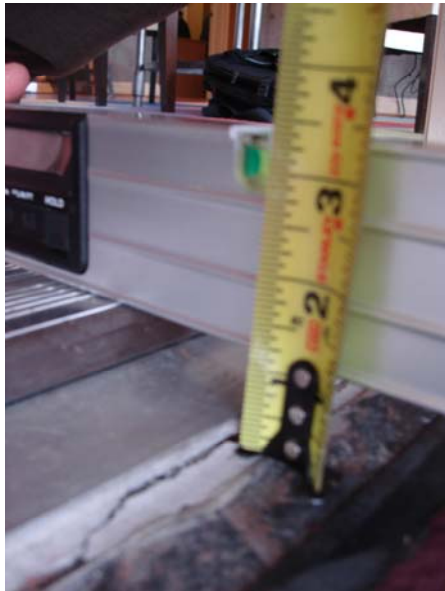
*Threshold
Measurement -
Exterior(#9975),left*

The front door threshold was more than 1-1/8 inches high at the exterior side and 1 inch high at the interior. This is more than the 1/2 inch high threshold maximum height (ANSI 4.13.8).

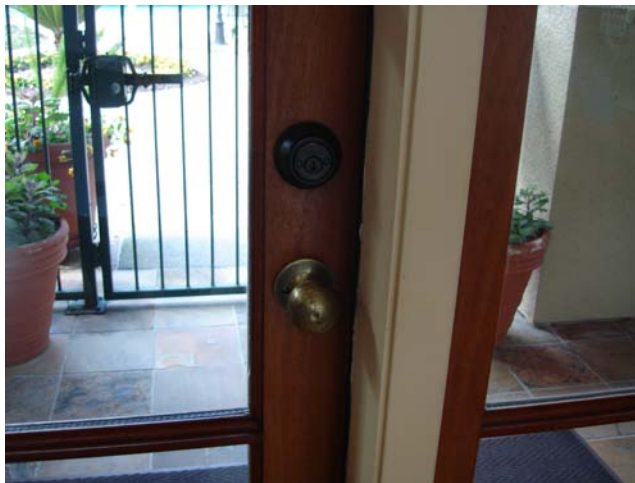
Leasing Office Door to Pool Area (#9983)

The interior hardware at the leasing office pool door was knob style hardware. Knobs are not accessible hardware. “Handles, pulls, latches, locks, and other operating devices on accessible doors shall have a shape that is easy to grasp with one hand and does not require tight grasping, tight pinching, or twisting of the wrist to operate.” (ANSI 4.13.9, ADA Std. 4.13.9).

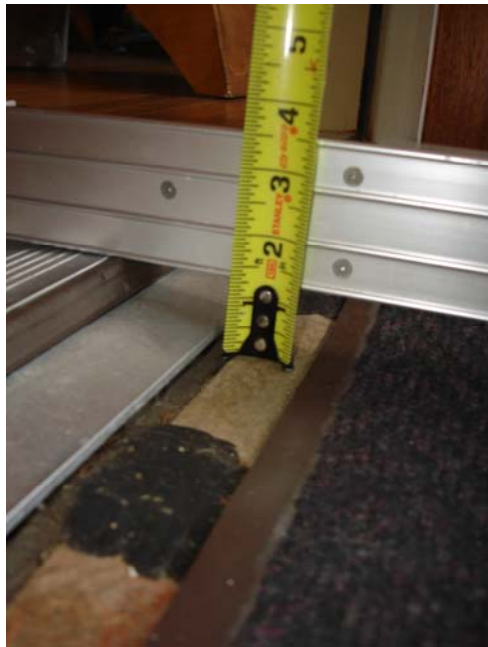
*Threshold
Measurement -
Exterior(#9981),
left*

The door threshold was more than 1-1/8 inches high at the exterior side and 1 inch high at the interior. This is more than the 1/2 inch high threshold maximum height (ANSI 4.13.8).

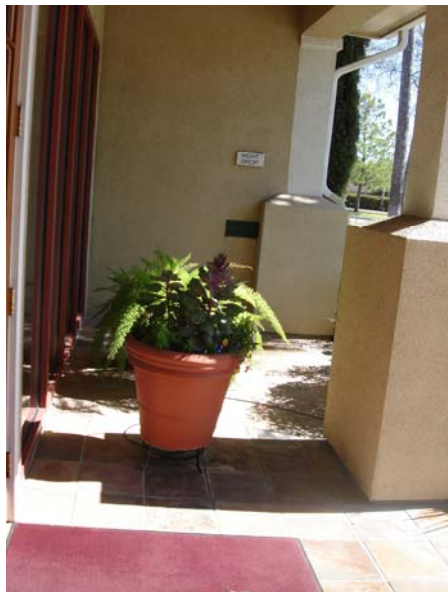
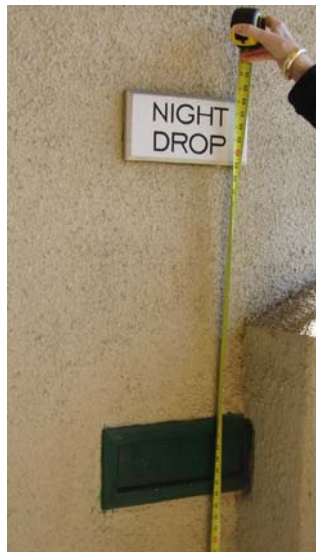
The night drop for rent was located at one end of the leasing office front entry area. This area was blocked with planters and no accessible route to the rent drop was provided.

Route to rent drop (#0913)

Night drop (#0910)

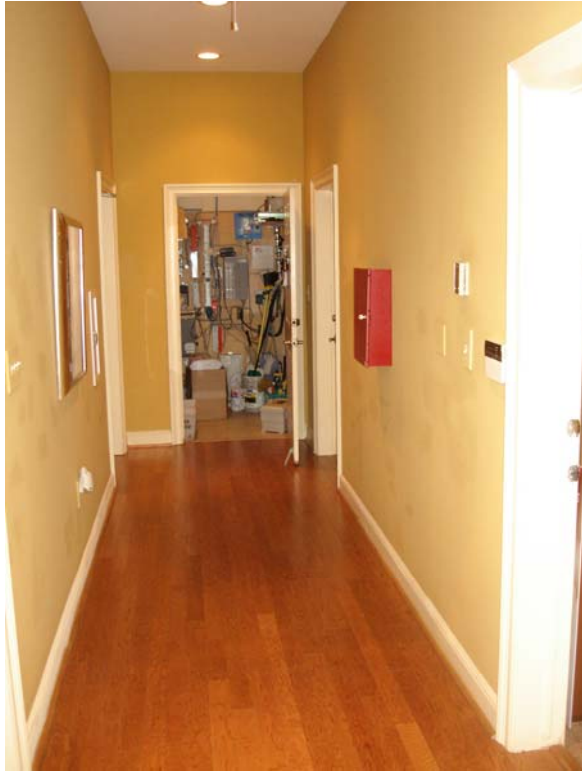
The leasing office and business center restroom is down a hall from the main reception area and the offices. Elements throughout this accessible route are required to comply with relevant portions of the ADA Standards.

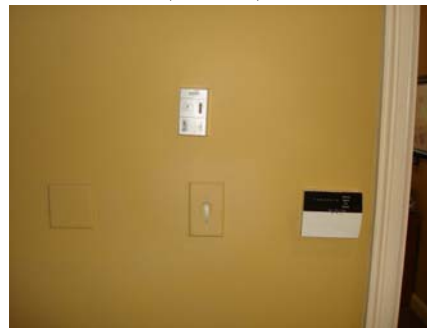
Corridor to Restroom (#9910), left Thermostat (#9911), below

The alarm box mounted in the hallway protruded more than 4 inches from the wall. "Objects projecting from walls (for example, telephones) with their leading edges between 27 in and 80 in above the finished floor shall protrude no more than 4 in into walks, aisles, corridors, passageways, or aisles." (ADA Std. 4.4.1)

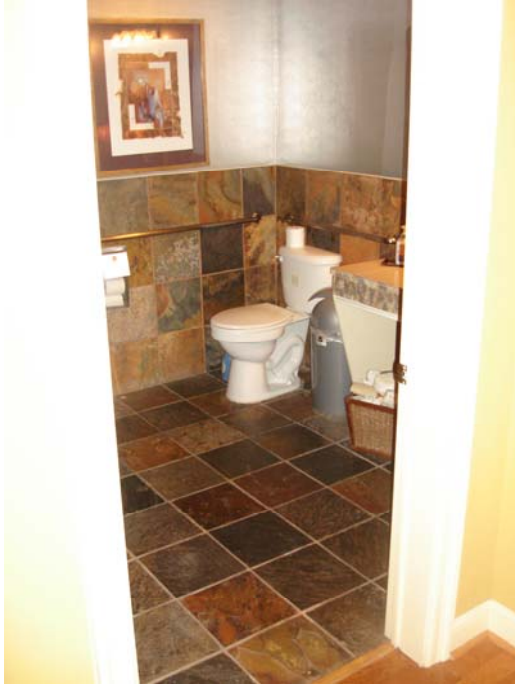
Restroom – View from Hall (#9914)

The restroom space was a single user space with a single toilet and lavatory. The lavatory was mounted in a counter with open space below.

The rim of the lavatory was mounted more than 34 inches (34-1/4 inches) from the floor surface. This does not comply with ADA requirements. "Lavatories shall be mounted with the rim or counter surface no higher than 34 in above the finish floor." (ADA Std. 4.19.2).

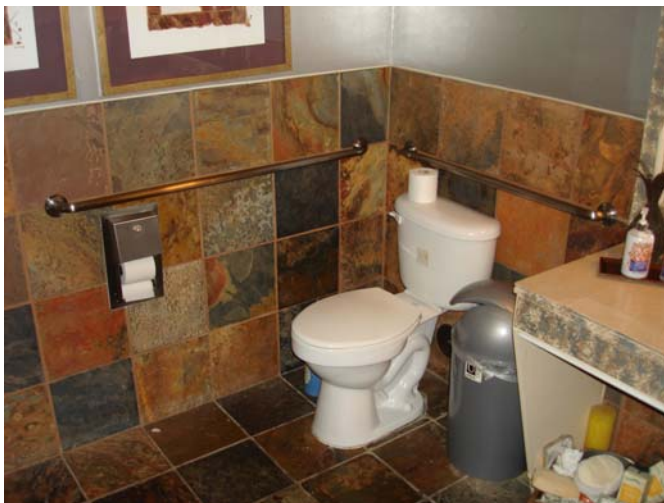
Toilet (#9921)

The Flush lever at the toilet was not on the open side of the toilet. "Controls for flush valves shall be mounted for use from the wide side of the toilet" (ANSI 4.16.5 and ADA Std. 4.16.5)

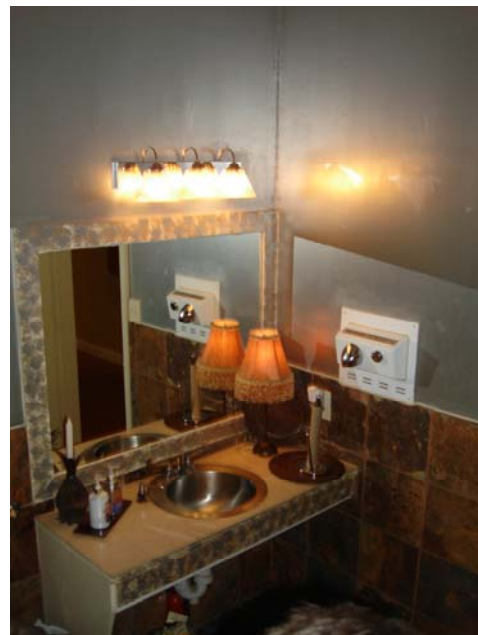
Hand dryer at side of lavatory (#9917)

The hand dryer was mounted with the control push button at 55-1/2 inches above the floor which is above allowable reach range of 54 inches. (ADA Std. 4.2.5, 4.2.6).

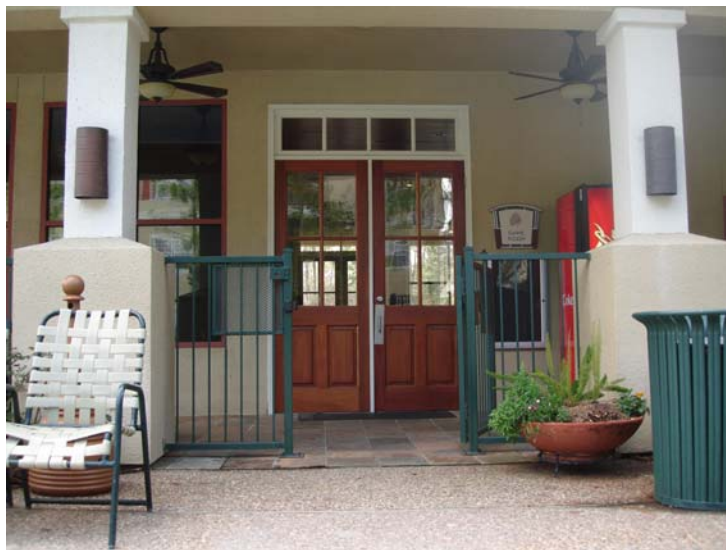
Game Room Exterior & Entry (#9983)

The game room is a public and common use area that is required to be "readily accessible to and usable by handicapped persons" (100.205 (c)(1)). The Guideline includes a chart titled "Basic Components for Accessible and Usable Public and Common Use Areas or Facilities" under Requirement 2. For each component or element, the appropriate ANSI Standard is cited (p 9504 24 CFR Vol. 56, No. 44). The components of this building that must comply with these requirements include the game room, game room recreational facilities (e.g. TV area), resident kitchen, and restroom.

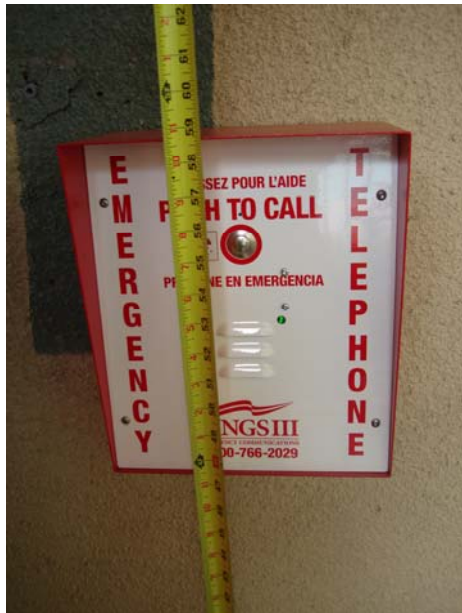
Emergency Call (#00053)

The emergency call unit located near the game room entry door was not within reach range. The operable button was located at 55-1/2 inches above the floor surface which is more than the 54 inches maximum allowed in ANSI (4.2.5, 4.2.6).

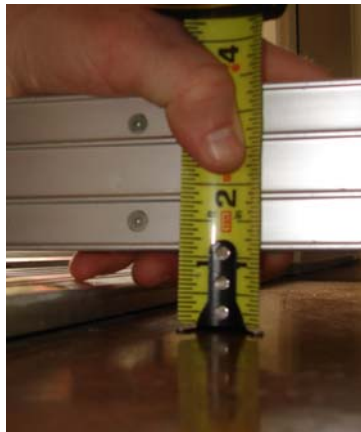
Pool door, interior threshold (#00008)

The thresholds at the game room entries were more than 1/2 inch maximum allowed at both locations (ANSI 4.13.8). At the pool side the exterior was 1-1/8 inches, the interior was 1 inch. At the front door, the exterior was 1-1/4 inches, the interior was 1 inch.

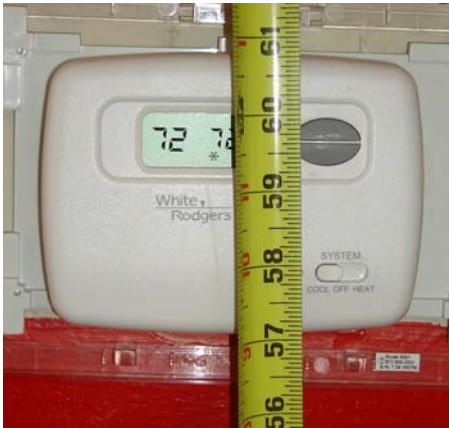
Thermostat (#00014)

The thermostat for this space was mounted at 60 inches above the floor which is above the 48 inch height allowed in the Guidelines (FHAG, Requirement 5, p9507).

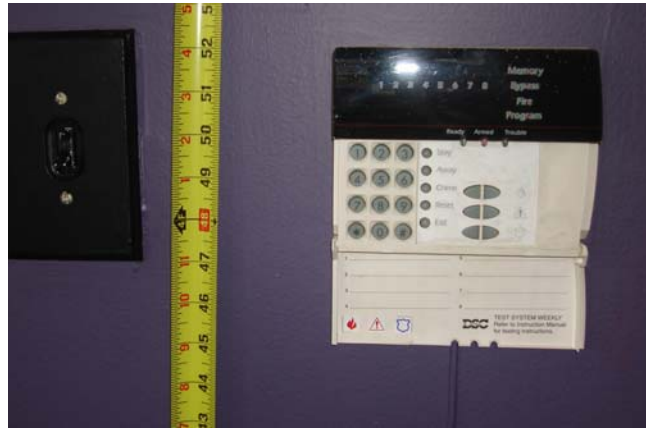
Security panel and switch (#00012)

The security control panel was mounted with topmost keys more than 48 inches above the floor (49-1/2 inches). Switches were also mounted more than 48 inches from the floor (49-1/2 inches). (FHAG, Requirement 5, p9507)

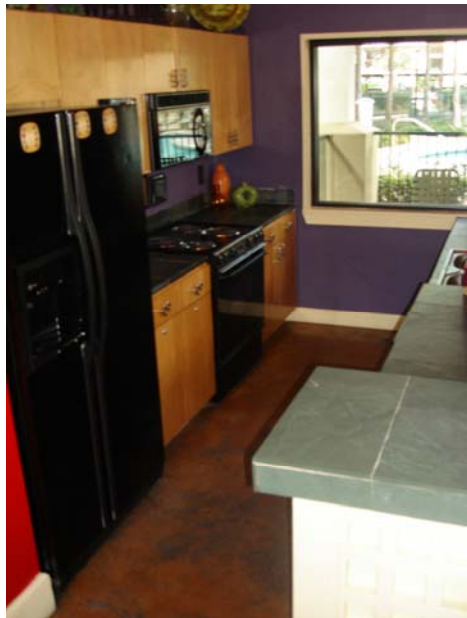
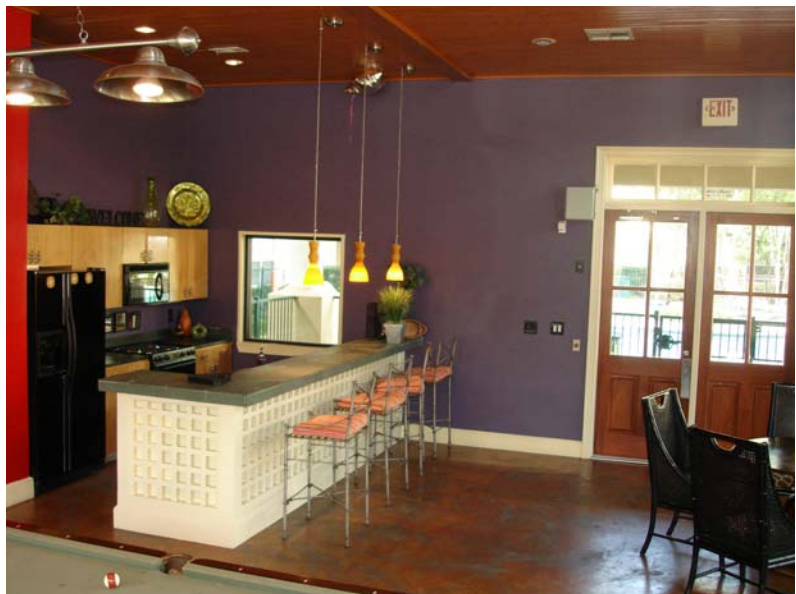
Game Room kitchen (#9995 - left, #0030 - below)

Resident Kitchen: kitchen is for resident use and is a public and common use area. The fixtures and fittings in this space must be usable. In particular the sink is required to comply with ANSI 4.19. The balance of the elements must have required space for clear approach and use and controls within reach range. (ANSI Table 2, Basic Components for Accessible Sites, Item 26)

- The sink counter was 35 inches above the floor (34 inches required). (ANSI 4.19.2.2)
- The sink did not have clear floor space of 30 inches by 48 inches in front of the bowl extending a minimum of 19 inches underneath the sink. No knee space was provided because the garbage disposal blocked knee space at the resident's kitchen sink (ANSI 4.19.2.1 and Fig. 31).

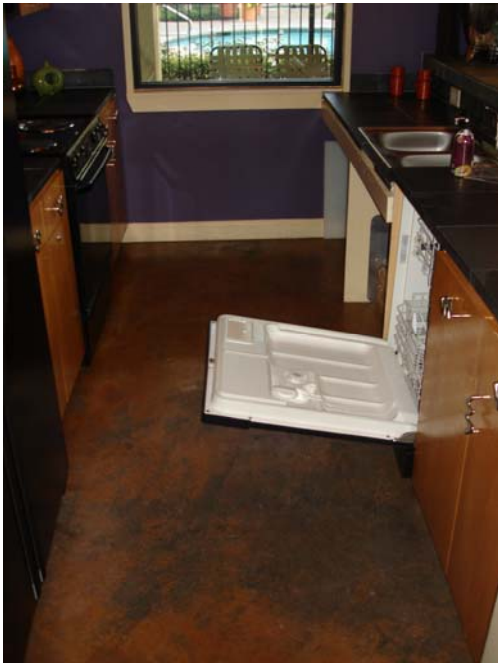
Dishwasher (#00020)

- The dishwasher did not have usable approach space. (100.205 (c)(1), FHAG #7, (1)(a))
- The refrigerator did not have required clear floor approach space. (100.205 (c)(1), FHAG #7, (1)(a)). The wall adjacent to the refrigerator obstructed the door opening so that it would not swing clear of the space required to approach the equipment in a parallel approach. The cabinets across from the refrigerator were less than 48 inches away (42 inches) and obstruct a front approach to the refrigerator.

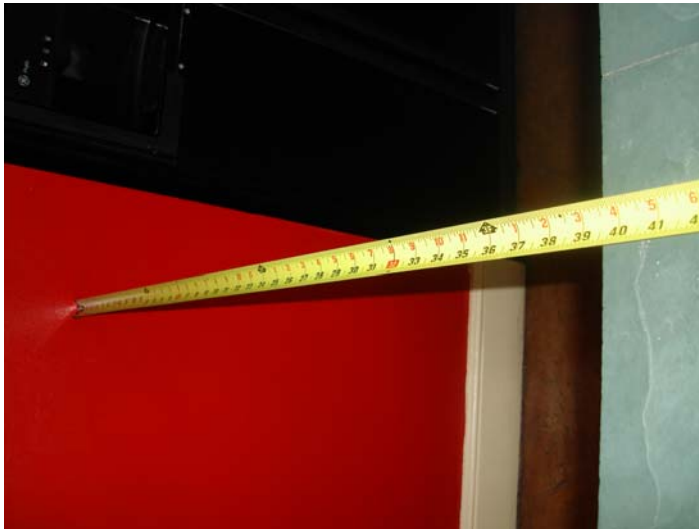
*Clear space at kitchen entry area
(#00035)*

- The distance from the counter and cabinets at the open end of the kitchen and the wall opposite was 39-1/2 inches. A minimum of 40 inches is required (FHAG, Requirement 7, (1)(b), p9511).

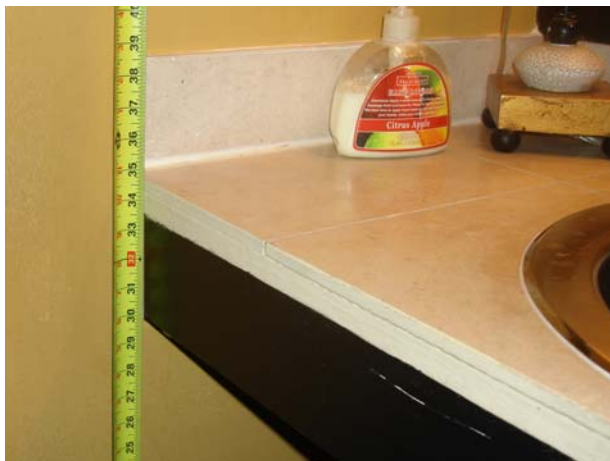
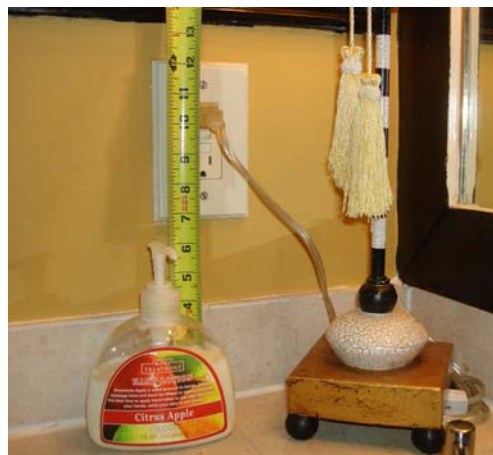
Top of lavatory (#00020)

The rim of the lavatory was mounted more than 34 inches (35 inches) from the floor surface and the pipes were not insulated. This does not comply with ANSI requirements. "Lavatories shall be mounted with the rim or counter surface no higher than 34 in above the finish floor." (ANSI 4.19.4).

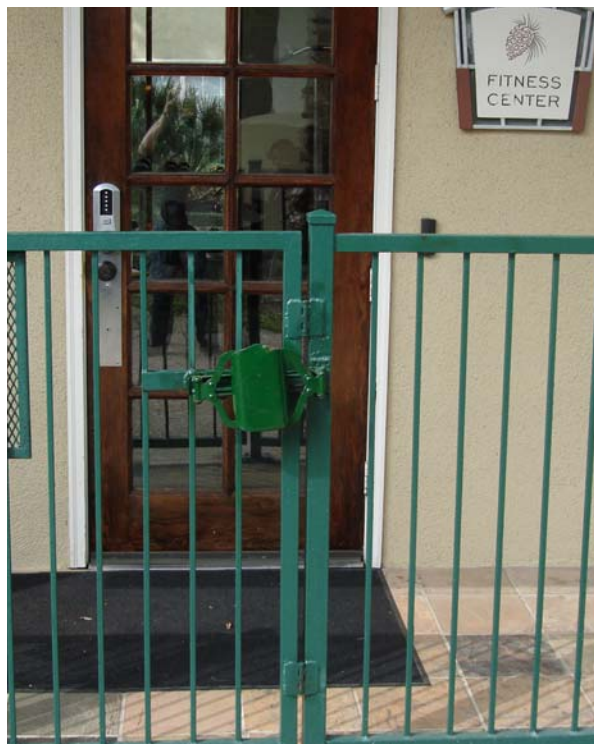
Fitness Room Entry (#00161)

The exterior door required use of a button lock pad.

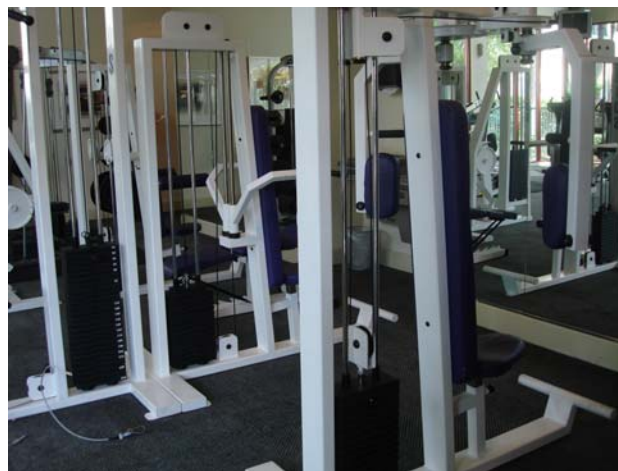
Fitness Room (#00070)

The equipment was located in the room in such a way that access to all types of equipment was not possible for person using a wheelchair.

Access to the drinking fountain and to the women's restroom was blocked by the equipment. The passage to the drinking fountain was 22 inches wide on one side and 24 inches on the other. The equipment also blocked the clear floor space at the fixture. The equipment was not easily movable by a single person. (ANSI 4.15.5).

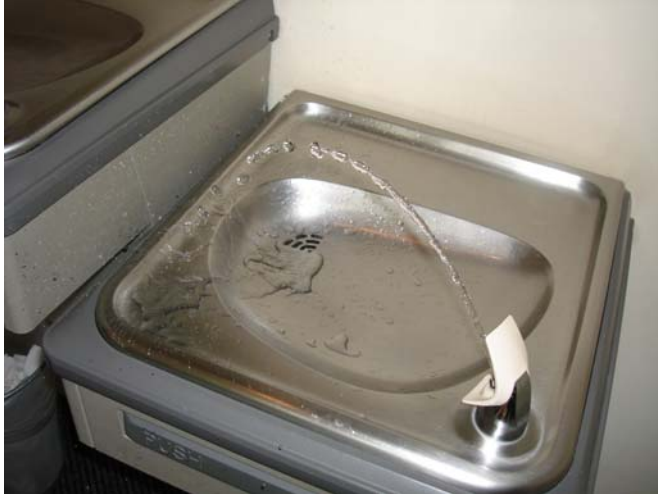
*Drinking fountain – water trajectory
(#0106), left*

The stream of water was not nearly parallel to the

front of the unit. (ANSI 4.15.2 “shall direct the water flow in a trajectory that is parallel or nearly parallel to the front of the unit.”) The paper towel dispenser and the hand sanitizer dispenser at the drinking fountain area were both above 48 inches above the floor forward reach (ANSI 4.2.5). The paper towels were at 61 inches and the Purell was at 51 inches.

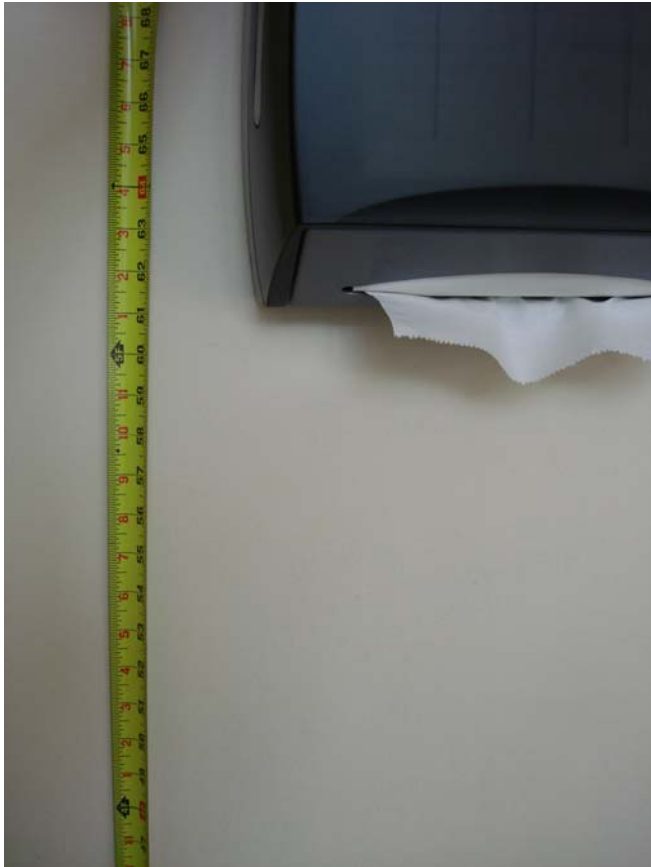
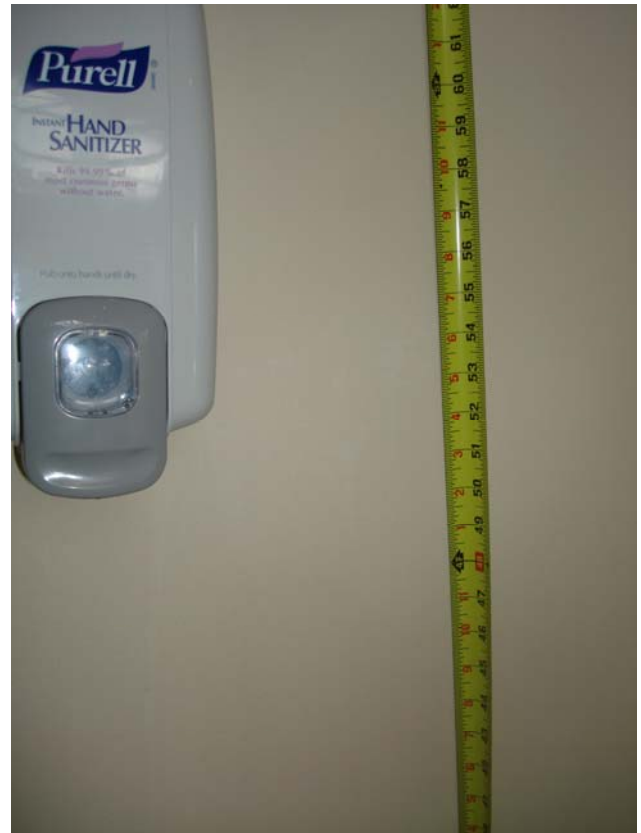
Paper towel holder (#0104), bottom left

Purell (#0105), below

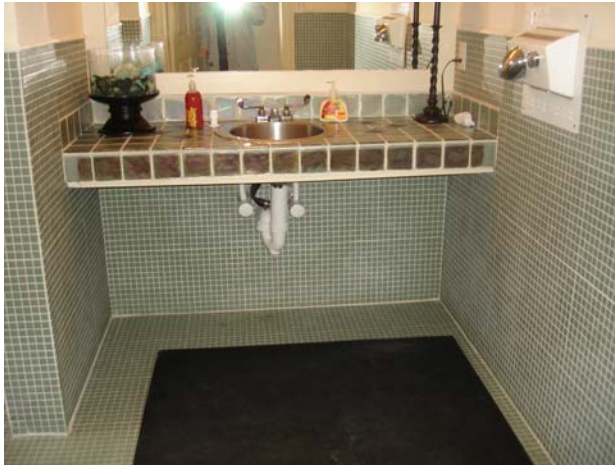
Women's Room Lavatory (#00087), above

The restroom space had two toilet stalls and a lavatory in a counter with open space below.

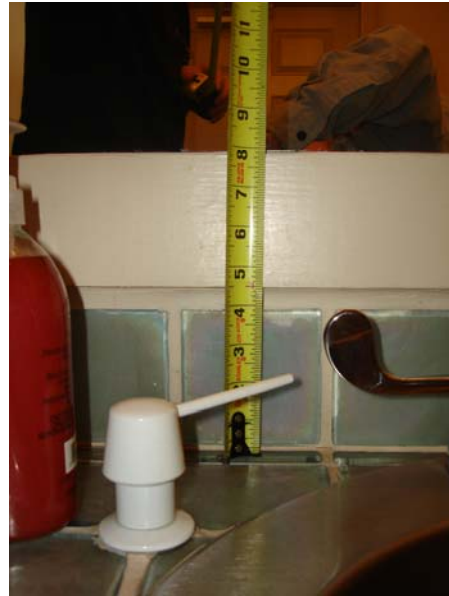
Women's room mirror height (#0126), right

The reflecting surface was 8 inches above the lavatory counter, which was at 34 inches above the floor, total 42 inches. The reflecting surface must be set at no more than 40 inches above the floor (ANSI 4.19.6).

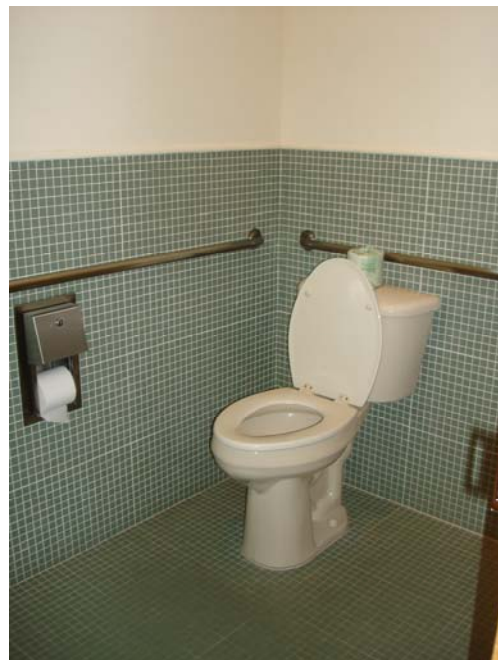
Women's Room Toilet (#00090)

The flush lever was not located on the open side of the toilet. (ANSI 4.16.5)

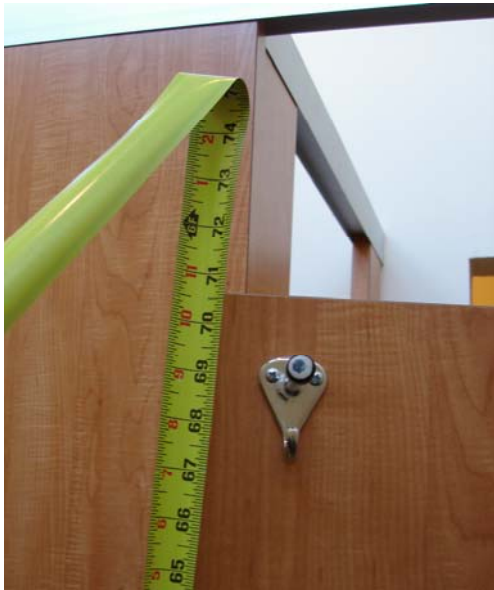
Hook in toilet stall (#0143)

The hooks in the toilet stall were at 67-1/2 and 69 inches above the floor which is above reach range (ANSI 4.2.5, 4.2.6).

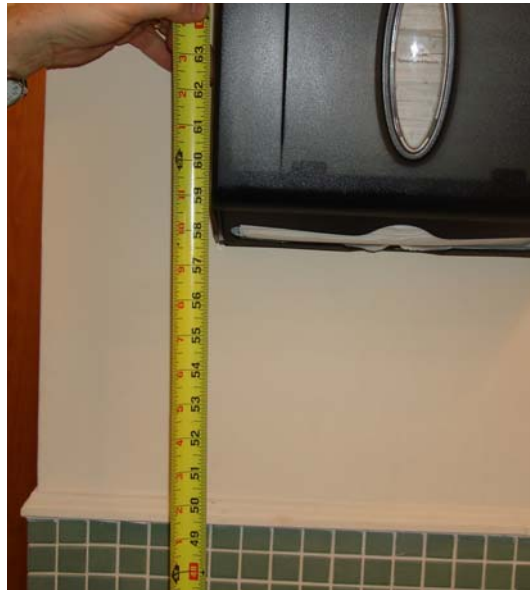
Paper towel dispenser (#00128)

The paper towel dispenser was mounted above the reach range of 54 inches (57-3/4 inches) to the paper towels (ANSI 4.2.5, 4.2.6).

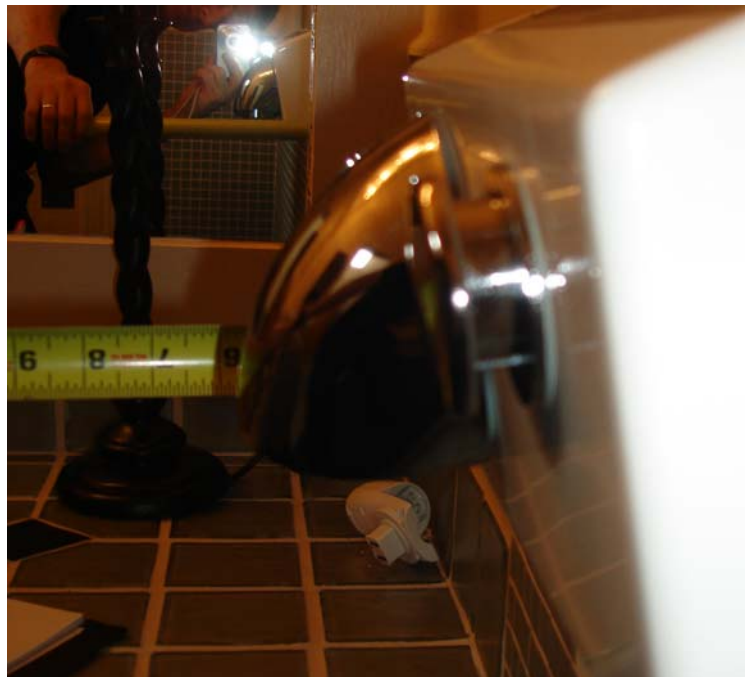
Hand dryer (#0131)

The hand dryer protruded from the wall more than 4 inches (6 inches). Wall mounted objects with their leading edges between 27 and 80 in above the floor shall not protrude more than 4 inches (ANSI 4.4.1)

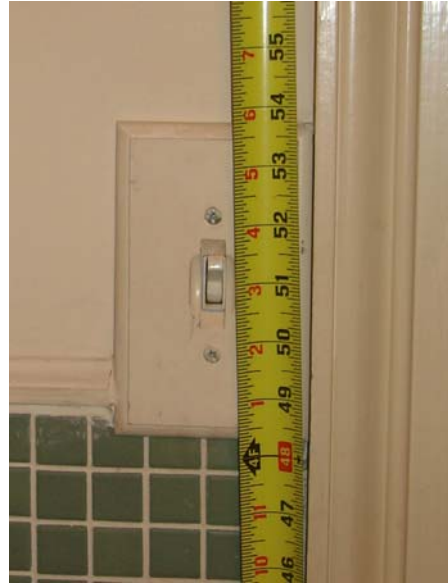
Light switch (#0134)

The light switch at this room was mounted at 51 inches above the floor. This is above the 48 maximum reach range permitted by the Guidelines (FHAG, Requirement 5, p9507)

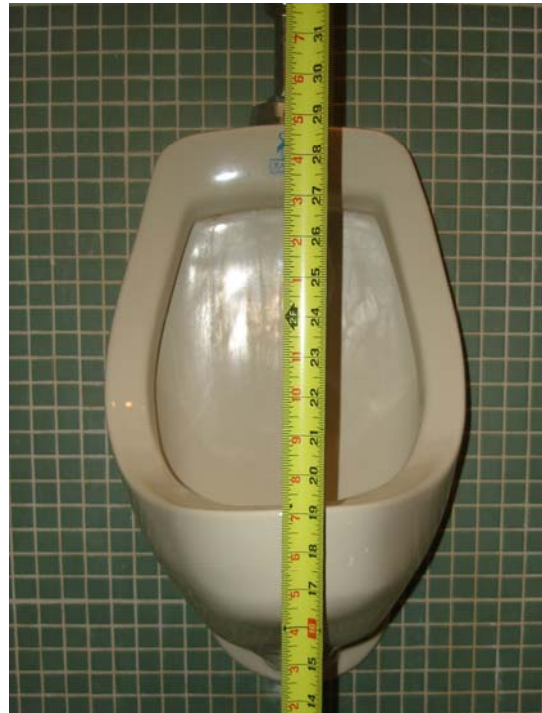
Men's Room urinal(#0154)

The urinal rim was more than 17 inches above the floor (19 inches) (ANSI 4.18.2).

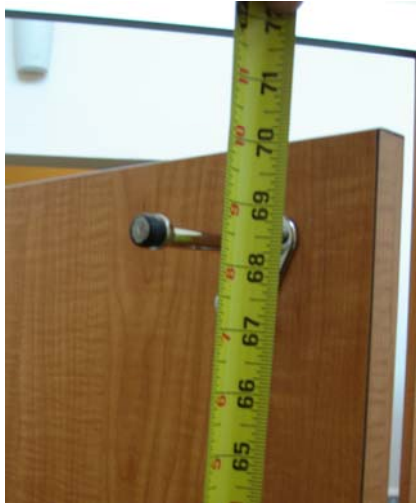
Hook in toilet stall (#0157)

The hooks in the toilet stall were mounted at 67-1/2 and 69 inches which is above the 54 inch reach range permitted (ANSI 4.2.5, 4.2.6).

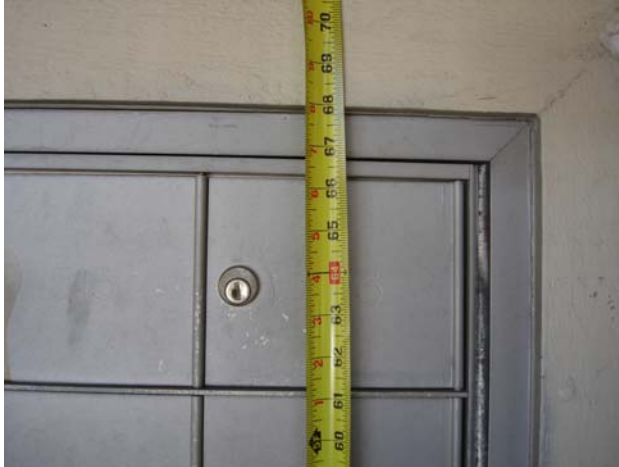
Mail box height to top row (#0829)

The mailboxes were numbered according the units. The locks of the top two rows of boxes were above reach range permitted of 54 inches (61-1/2 to 64 inches and 56-1/4 to 58-1/4 inches). The mail boxes that were not within reach range included boxes serving ground floor units covered by the Fair Housing Act.

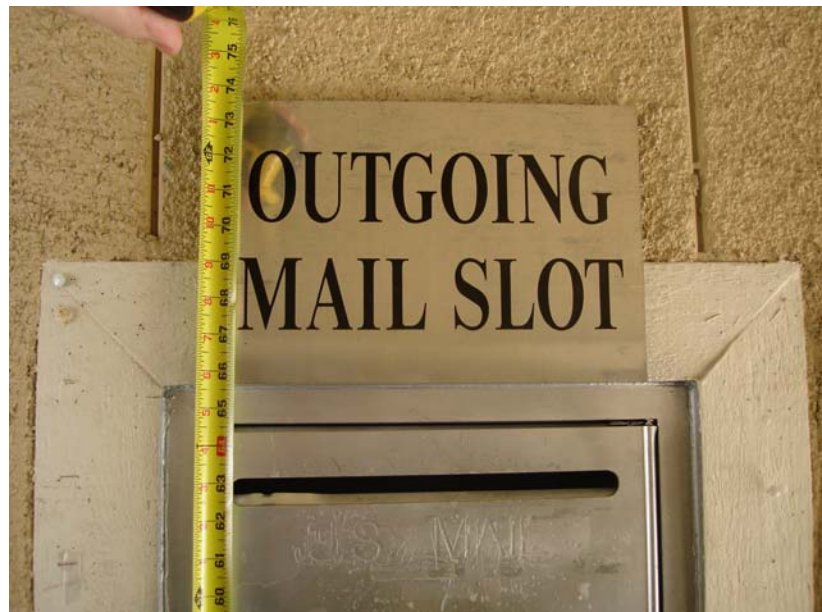
Outgoing Mail Slot (#0835)

The outgoing mail slot was at 63 inches above the ground surface. This is above the 54 inch side reach required by ANSI 4.2.6.

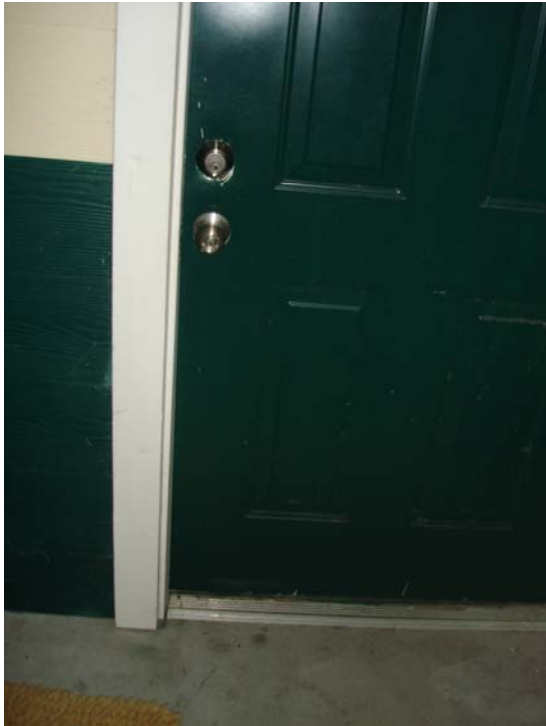
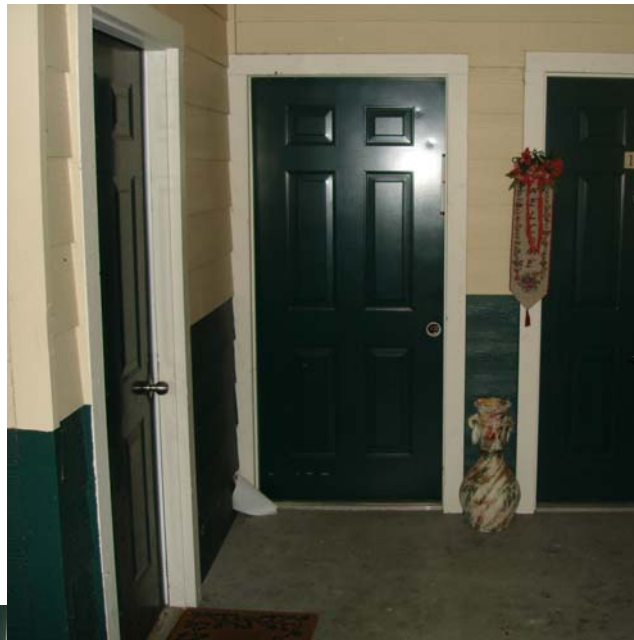
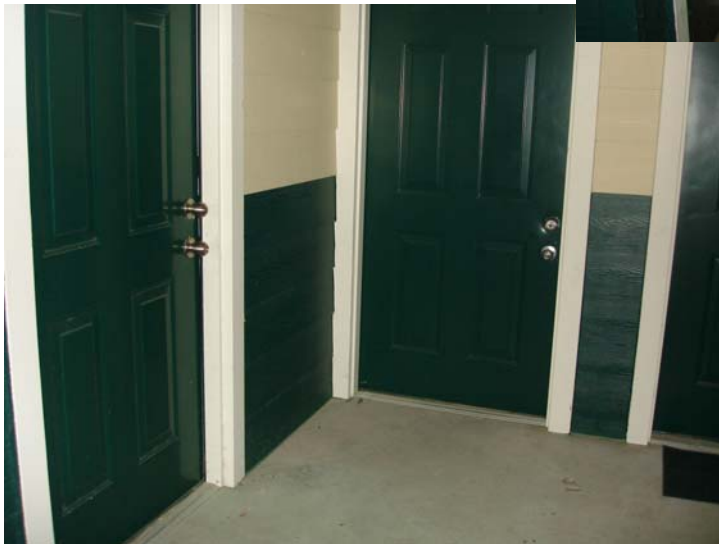
*Garage Door at Building 6(#0505), left
Breezeway at Building 14 with Garage Doors
(#0272), below
Breezeway at Building 4 with Garage Doors
(#0367), below left*

Pedestrian entries to garages that were not attached to specific units were located in the breezeways of Buildings 2, 3, 4, 5, 6, 8, 9, 11 and 14 (9 buildings). At each building, there were 3 garages available for rent. All of these doors had knob style hardware and required pinching and twisting to operate the lock latch mechanism. (ANSI 4.13.9).
